Assessment of water resources management, utilization and conservation in Mombasa polytechnic

ABSTRACT

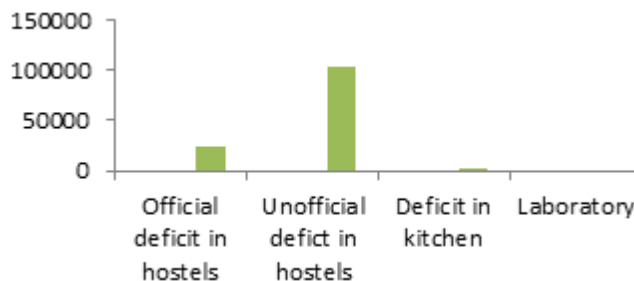
Figure 3. Official and unofficial water deficit in Mombasa polytechnic.

The official deficit in hostels , kitchen, laboratory and the unofficial deficit caused by survivors was quantified as shown in Figure 3

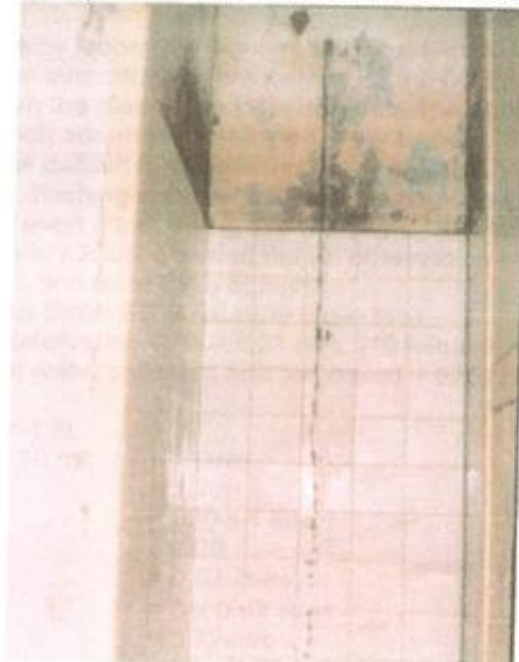
Appendix 2 : Running water in bathroom of block SCB ground floor.

Photograph of running water in the bathroom Block SC B ground floor)

Water wastage and misuse in Mombasa polytechnic caused by student ranges from open and running taps while brushing their teeth, excessive use of water to rinse cloth while washing, leaving taps unfastened when they find them dry, opening showers and leaving the water running before the start of bathing and frequent bathing by students (morning, afternoon and evening) and the use of parlour for bathing by day scholars. Wastage attributed to college management were cases like overflowing water while watering the flower beds, overflow of the storage tanks in the hostel building blocks and overhead tanks as observed in block M and SC (C), cases of burst pipes due to ageing, broken

showers as shown in Appendix 2, lack of water register at the pump house and slow response by the maintenance department to reported faulty cases, easy access of the bathroom and toilets by outsiders, negligence by the catering department by leaving water to overflow their cooking utensils, lack of assistant to the pump attendant, negligence by the laboratory technician to fasten the taps in the evening before leaving for home and faulty/leaking facilities . During the study period, a total of 26 leaking taps were observed in different departments as shown in Table 4. Leakage in blocks SC A, B and C taps were quantified at 533.28 liters per day. Rainy season run off and roof collected water were lost to the ocean as a result of pavements. This increased their run off rates, as there was no collection point and storage tanks for them.

- ◆ Maintenance department takes long to respond to reported cases for example on 9/2/2005 a burst pipe from the water distribution to the fire point was sighted as from 4.00 p.m. – 9.00 a.m. the next day (10/2/2005). Broken showers in block B ground floor took three (3) days before being attended to. A photograph was taken and its shown below here.

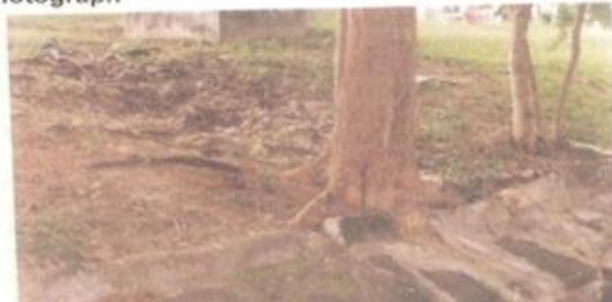
Soil erosion photograph

Rainwater should be harvested to supplement the supply system already existing. The run-off from the rain should also be collected and be used instead of letting it to drain into the ocean. The environment should also be improved by planting grasses in all bare lands in the college. This will improve the underground water recharge system and reduce soil erosion, which is now rampant in the upper grounds of the college. The washed soil and debris are filling up the open drainage system in the college, which might lead to flooding in future. They are also leaving the college without topsoil meaning eco-system balance is being interfered with.
